Title: Performance of coatings on acetylated Scots pine sapwood in outdoor exposure

Report code: 3.330-366

Date: 11 April 2005

SHR Timber Research
"Het Cambium"
Nieuwe Kanaal 9b
PO Box 497
6700 AL Wageningen

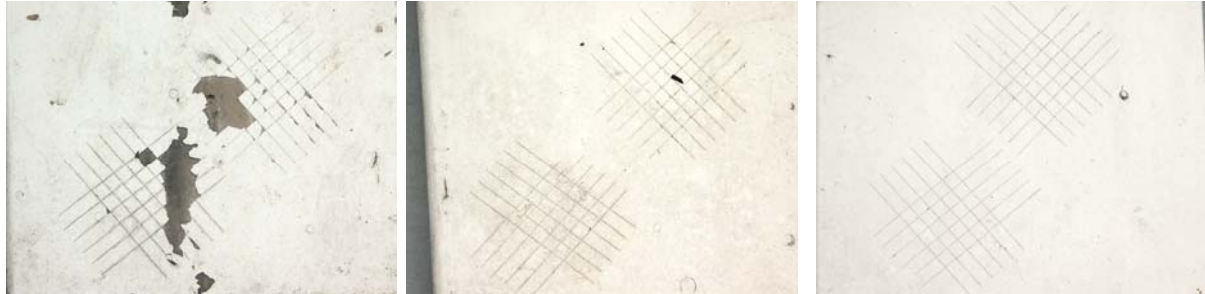
In table 3 the results of the adhesion under dry and wet conditions are shown. The thickness of the coating layer (based on 1 sample per coating system and wood treatment) and the wood's moisture content during the "adhesion under wet condition"-test are given too. In figure 2 a photographic overview is given of adhesion tests of untreated and acetylated (with and without residual acetic acid) finished with an opaque white acrylic coating. For most untreated wood samples the adhesion could not be determined because almost no coating was left on the surface. A remarkable better adhesion was found for the acetylated samples compared to the untreated samples finished with an opaque white acrylic coating (system 4). The bad adhesion for the acetylated samples finished with opaque alkyd coatings is caused by the loss of intercoat adhesion. In general the acrylic coatings on acetylated wood showed the best adhesion.

Figure 2. Adhesion test (ISO 2409) under wet conditions of untreated (left), acetylated and acetylated with residual acetic acid finished with an opaque white acrylic coating after 9½ years of outdoor exposure.

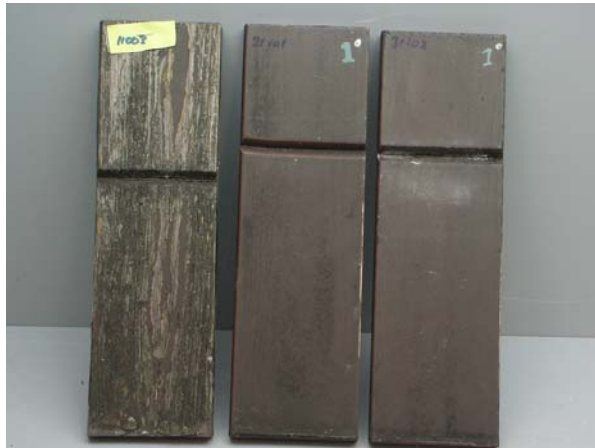
Coating system 1 – Transparent teak coloured alkyd

The coating of the untreated samples was almost completely disappeared. All untreated samples had moderate to severe wood decay.

There was not much difference between acetylated, acetylated with residual acetic acid and hailed or not hailed samples. All acetylated samples had (many) cracks in the coating. As a result of degradation of the coating itself, there were also many superficial cracks in the coating. There was severe mould growth on the coating. One of the acetylated samples had some wood decay.

Untreated (left), acetylated and acetylated with residual acetic acid panels finished with a transparent teak coloured alkyd coating after 9½ years of outdoor exposure.

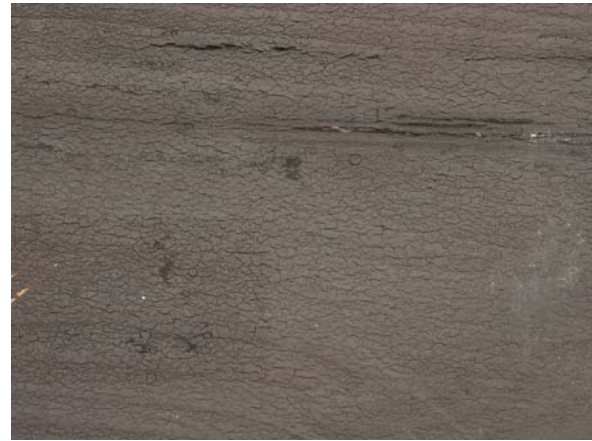
Cracking of coating surface (sample 21004) as result of coating degradation after 9½ years of outdoor exposure.

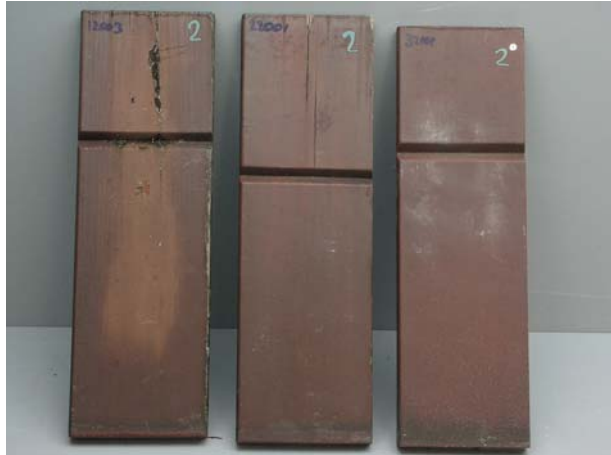
Coating system 2 – Transparent teak coloured acrylic

The coating of the untreated samples had many cracks and some flaking. All untreated samples had moderate to severe wood decay.

There was not much difference between acetylated, acetylated with residual acetic acid and hailed or not hailed samples. All acetylated samples had some cracks in the coating. As a result of degradation of the coating there were also many superficial cracks in the coating. There was no mould growth on the coating's surface. One of the acetylated samples had some wood decay in the centre of the board.

Untreated (left), acetylated and acetylated with residual acetic acid panels finished with a transparent teak coloured acrylic coating after 9½ years of outdoor exposure.

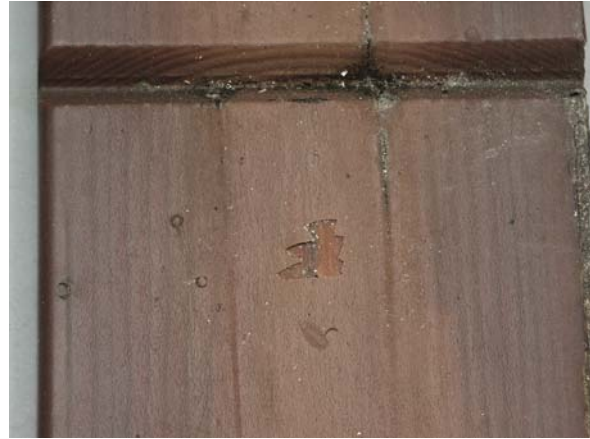
Cracking of coating surface (sample 12003) as result of coating degradation after 9½ years of outdoor exposure.

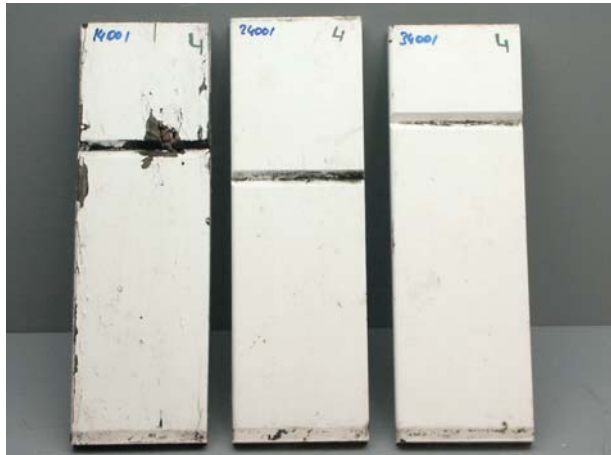
Coating system 4 – Opaque white acrylic

The coating of the untreated samples had many cracks and some flaking. All untreated samples had moderate to severe wood decay.

There was not much difference between acetylated, acetylated with residual acetic acid and hailed or not hailed samples. The coating on the acetylated samples had a few cracks and showed no signs of flaking.

Wood decay was found in 2 out of 13 acetylated samples.

Untreated (left), acetylated and acetylated with residual acetic acid panels finished with an opaque white acrylic coating after 9½ years of outdoor exposure.

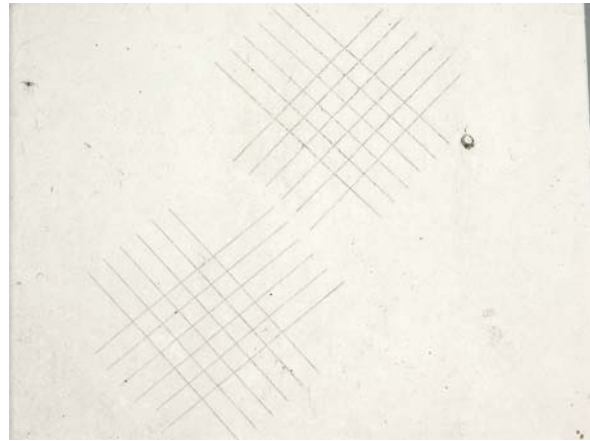
Adhesion test (ISO 2409) under wet (top) and dry conditions of acetylated (with residual acetic acid) Scots pine finished with an opaque white acrylic coating after 9½ years outdoor exposure (sample 34004)

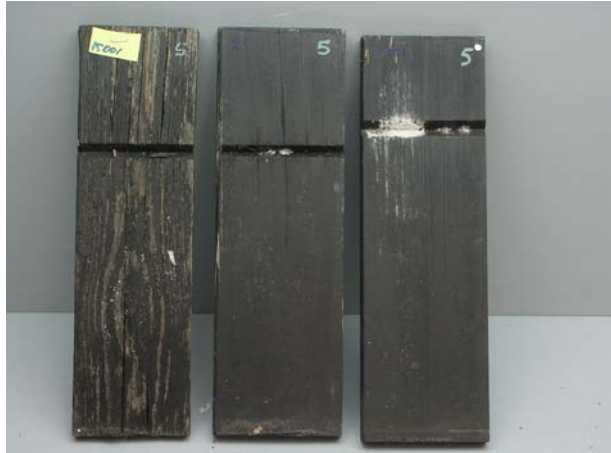
Coating system 5 – Opaque black acrylic

The coating of the untreated samples had many cracks and flaking. All untreated samples had moderate to severe decay.

There was not much difference between acetylated, acetylated with residual acetic acid and hailed or not hailed samples. The coating on the acetylated samples had many small cracks due to coating degradation and little amount of flaking. Moderate to severe wood decay was found in 6 out of 13 acetylated samples.

Untreated (left), acetylated and acetylated with residual acetic acid panels finished with an opaque black acrylic coating after 9½ years of outdoor exposure.

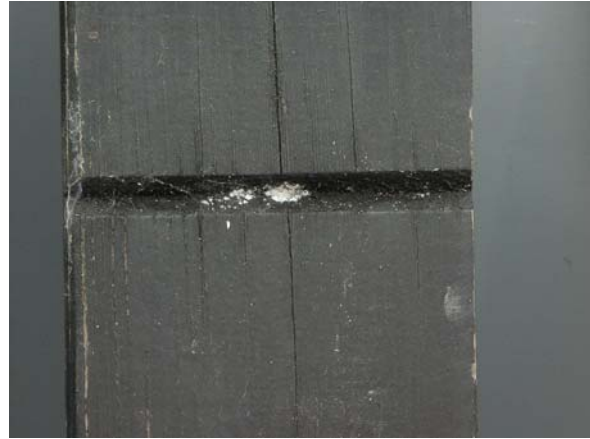
Wood cracks in acetylated Scots pine finished with an opaque black acrylic coating after 9½ years outdoor exposure (sample 25001).

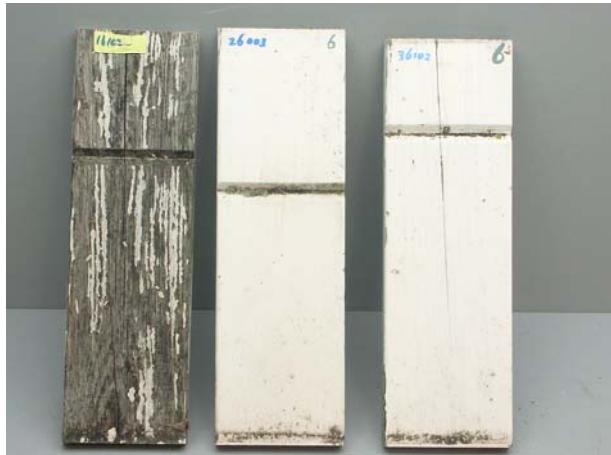
Coating system 6 - Opaque white alkyd

At the surface of the untreated samples hardly any coating was left. All untreated samples had severe wood decay.

There was not much difference between acetylated, acetylated with residual acetic acid and hailed or not hailed samples. The coating of all acetylated samples had many cracks and some degree of flaking. All acetylated samples were sound (no wood decay). Blue stain was penetrating through the coating at all samples.

Untreated (left), acetylated and acetylated with residual acetic acid panels finished with an opaque white alkyd coating after 9½ years of outdoor exposure.

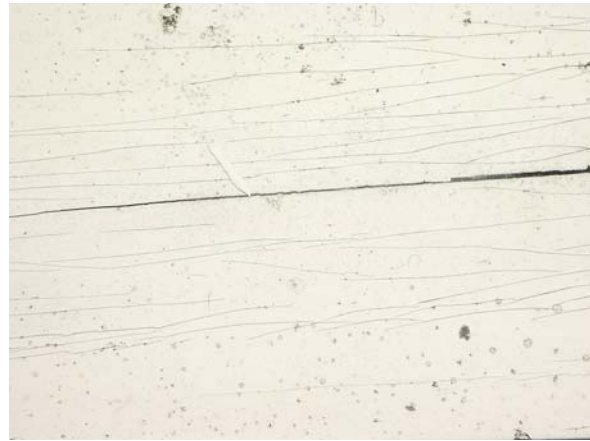
In outdoor exposure, blue stain attacked finished acetylated wood after a few months. Although the wood moisture content of acetylated wood is lower, blue stain appeared locally on some surfaces, and is causing degradation of the coating at sound spots (cracking). The amount of acetic acid does seem to influence the development of blue stain fungi, however, the exact nature of how blue stains develop in acetylated wood is not known.

Wood cracks, cracks in the coating and degradation of the coating layer by blue stain fungi of acetylated (with residual acetic acid) Scots pine finished with an opaque white alkyd coating after 9½ years outdoor exposure (sample 36102).

It is advised to start a new outdoor exposition test for modern coating systems and with wood treated in an up to date acetylation process (possibly in combinations with anti-blue-stain treatment). Besides testing of coating performance on panels (according to EN 927-3), an evaluation of coating performance on joinery in practice is recommended.

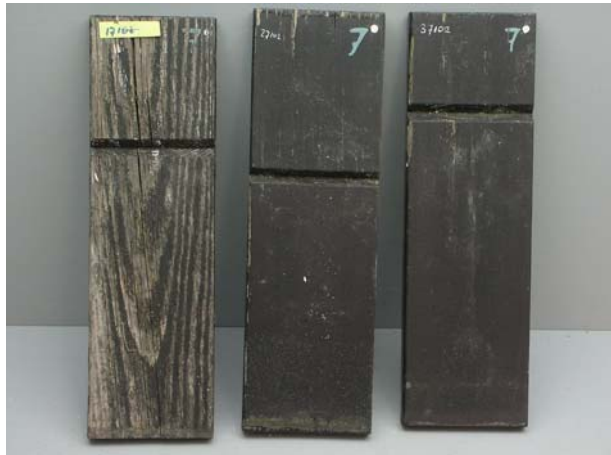
Coating system 7 – Opaque black alkyd

There was hardly any coating left at the surface of the untreated samples. All untreated samples had moderate to severe decay.

There was not much difference between acetylated, acetylated with residual acetic acid and hailed or not hailed samples. The coating of the acetylated samples had many cracks and some degree of flaking. Out of 14 acetylated samples 7 had moderate to severe wood decay.

Untreated (left), acetylated and acetylated with residual acetic acid panels finished with an opaque black alkyd coating after 9½ years of outdoor exposure.

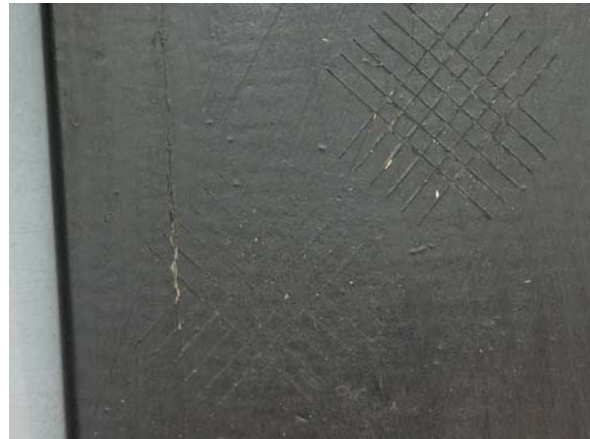
Adhesion test (ISO 2409) under wet (top) and dry conditions of acetylated (with residual acetic acid) Scots pine finished with an opaque dark alkyd coating after 9½ years outdoor exposure (sample 37003).
