Title: Performance of coatings on acetylated Scots pine sapwood in outdoor exposure

Report code: 3.330-366

Date: 11 April 2005

SHR Timber Research
"Het Cambium"
Nieuwe Kanaal 9b
PO Box 497
6700 AL Wageningen

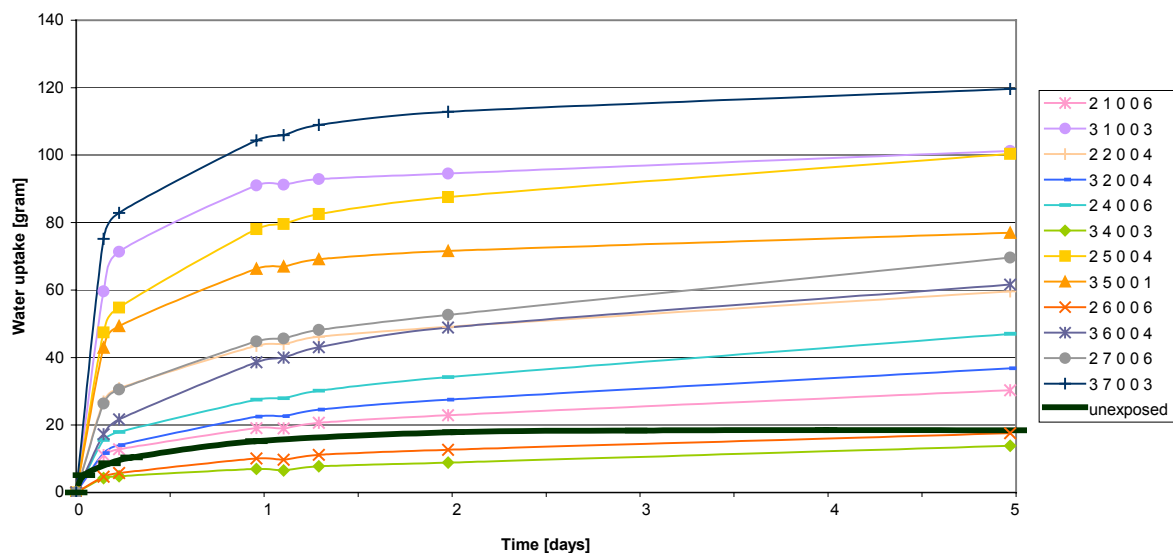
Figure 3. Water uptake of the acetylated samples compared to “fresh” Scots pine sapwood.

In figure 3 the amount of water uptake of the acetylated samples compared to unexposed Scots pine sapwood is shown. The water uptake of the acetylated exposed Scots pine samples was in most cases higher than the water uptake of unexposed Scots pine sapwood. This confirms the conclusion that part of the acetylated wood was decayed (due to too low acetyl content, see paragraph 3.4) and/or colonised by blue stain fungi. However, the surface of the acetylated wood samples was sufficiently acetylated to prevent wood decay.
