WEATHERING

ABOUT ACCOYA®

V08.15 – these guidelines have been written for professionals wishing to use Accoya to create beautiful, reliable and highly durable end products. Should you require further information or have any comments about this document, please contact Accsys through www.accoya.com.

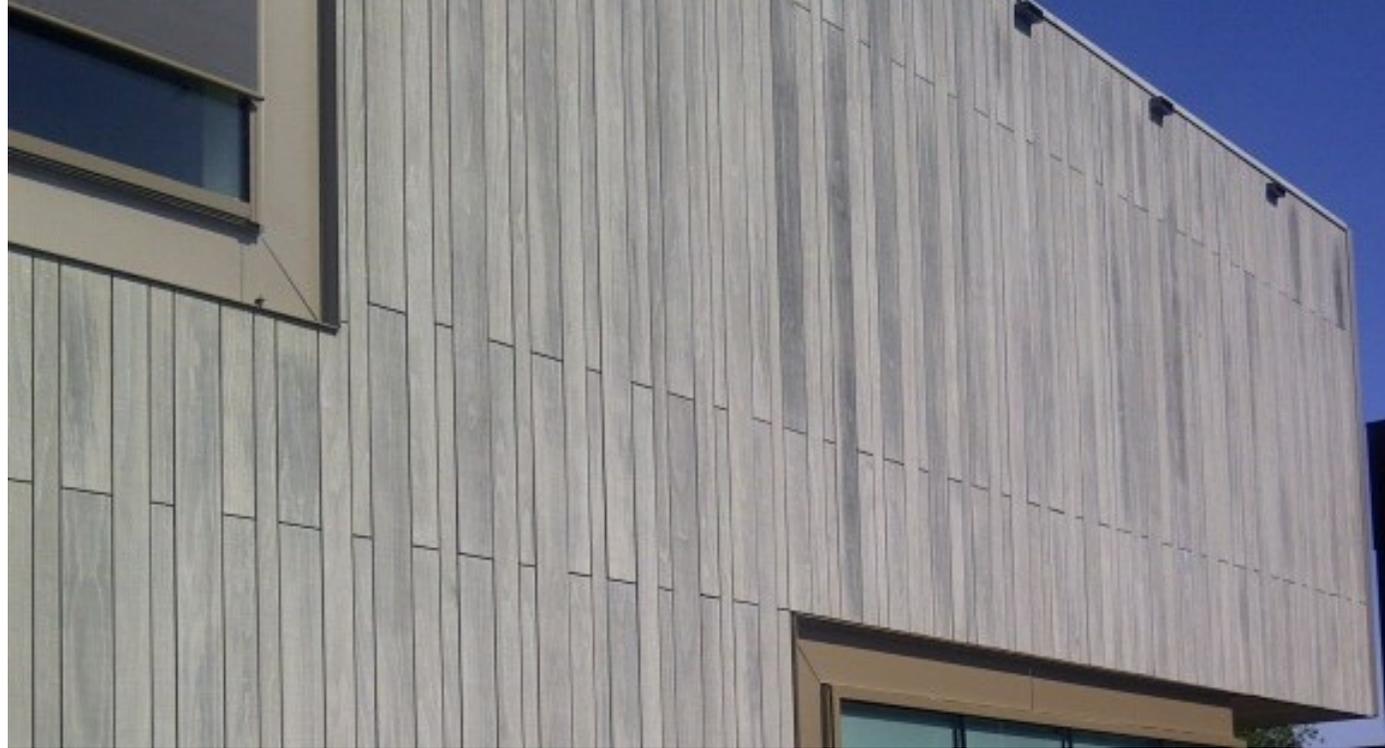
An example of such a blotchy transition period is shown in the image above (Dutch cladding project approximately a year after installation). If such 'blotchiness' appears in decking (as in the example on page 6), it is easiest cleaned when the wood is uncoated.

However, prior to turning grey, uncoated Accoya will go through a phase of bleaching where it turns a lighter shade of its normal colour. Surface growths are particularly apparent in this intervening period and can vary in level from board to board. This will become less distinguishable and objectionable after full (even) greying, but in this transition period the surface of Accoya may look blotchy.

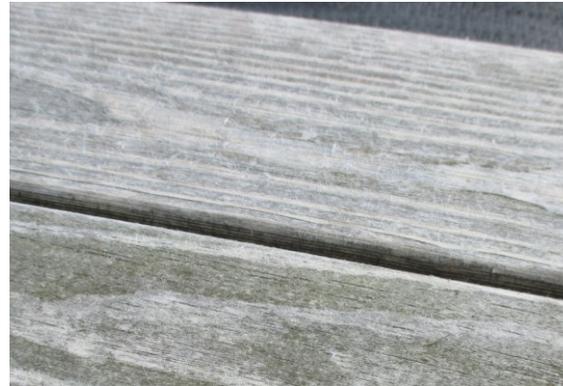
Natural occurring surface fibres on decking.

The higher the amount or intensity of UV the surface is subject to, the faster this process will develop. It should be noted that these fibres are formed on all exposed wood species, including Accoya, particularly on flat surfaces like decking. A ribbed deck profile will tend to cause an accumulation of these fibres, making it all the more noticeable.

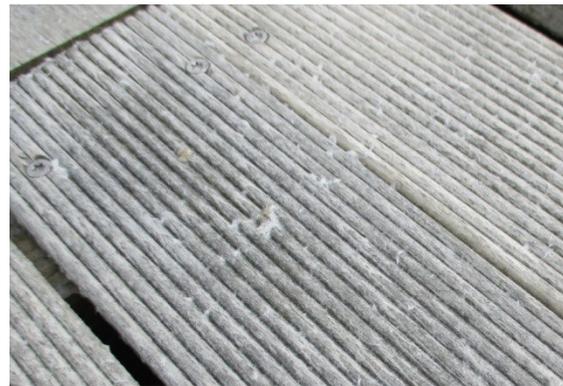
Fibres may get trapped in ribbed surface profiling.

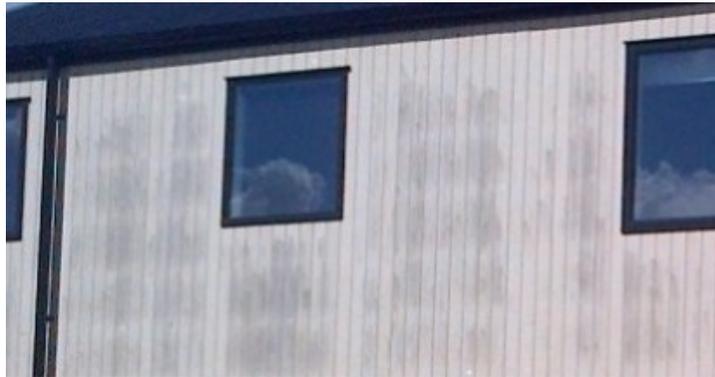
A New-Zealand housing project with a very distinct batten silhouette showing in the cladding surface.

Dryer conditions mean less mould growth, which is why the interfaces are clear where the rest of the board surface shows mould. Note that this effect can be observed on any façade with any kind of cladding or panelling material.

Some projects have shown a distinct pattern reflecting the sub-frame behind the Accoya. This is caused by heat transfer from the building to the Accoya boards, which will decrease the average moisture content at the location of the interface.

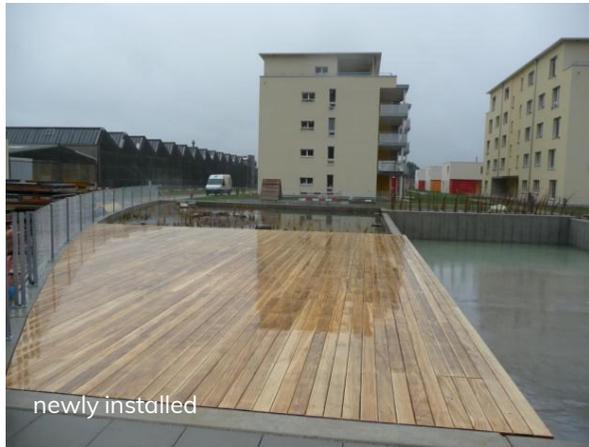
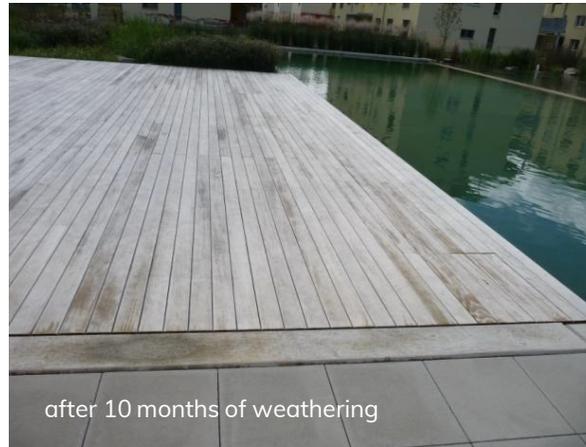
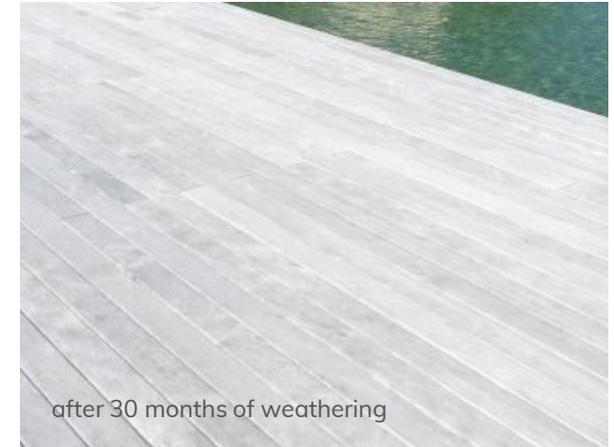
PUBLIC POOL DECKING, OESINGEN, SWITZERLAND

This deck in Oesingen was photographed when newly installed (left), after 10 months (middle) and after 30 months of weathering (right).

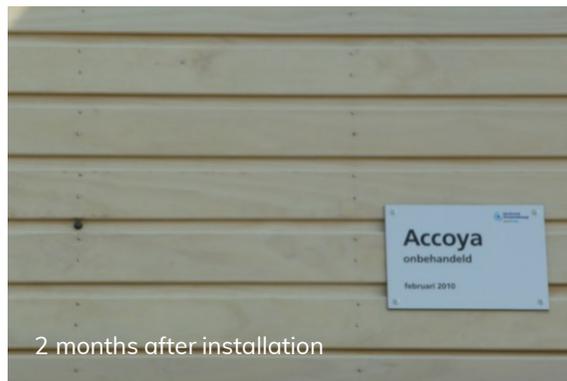
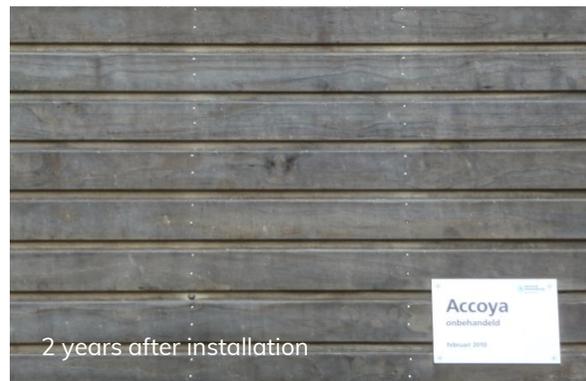
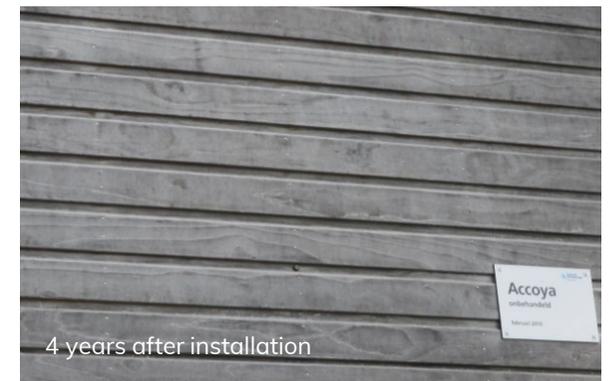
OFFICE CLADDING, VROOMS-HOOP, THE NETHERLANDS

A part of the South facing façade was cladded with Accoya in April 2010, with no maintenance since. The pictures below (left to right) show this cladding in July 2010, 2012 and 2014.

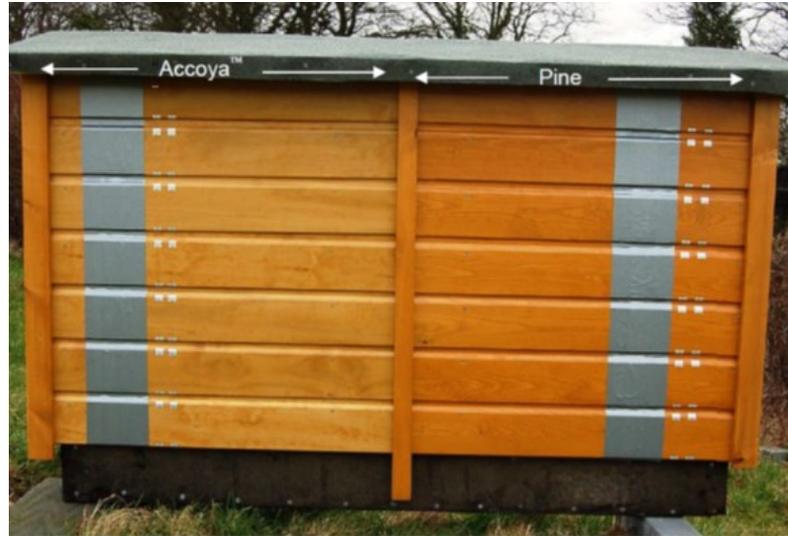
A south-facing cladding rig was set up at BM Trada for the comparative performance evaluation of Accoya and unmodified pine coated with a semi-translucent stain.

The translucent stain system consisted of a pigmented primer with two topcoats. The cladding boards used were machined to a rebated shiplap profile with the upper edge rounded to a radius of $\pm 10\text{mm}$.

Test set-up at the start of the exposure in February 2008

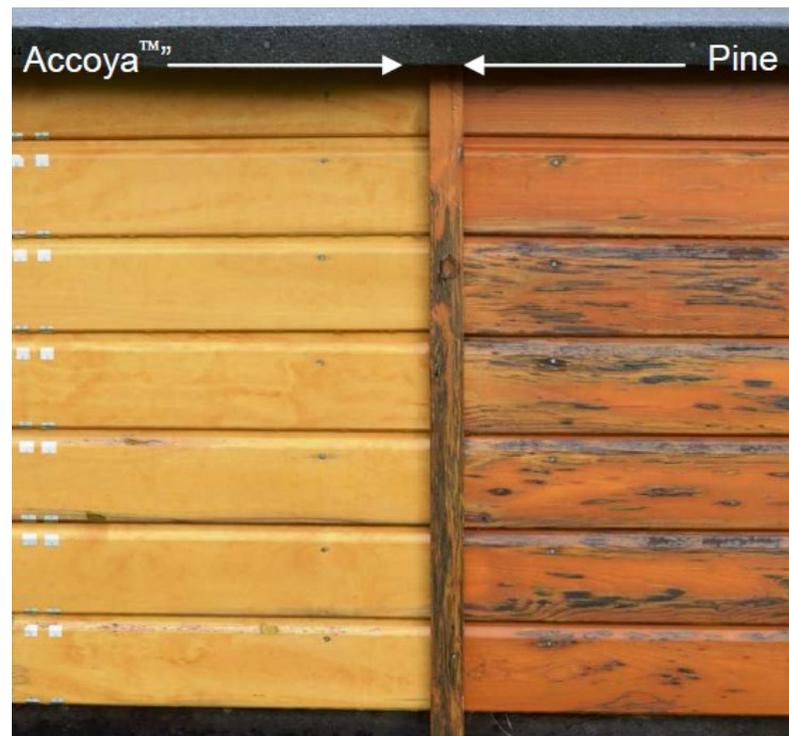
After nearly 7 years of south-facing exposure in a challenging environment the Accoya boards were found to be in a largely serviceable condition with only 2 of the 7 cladding boards showing discernible evidence of stress in the form of mould or mil-dew growth.

Test set-up after 7 years of exposure in January 2015

The pine boards were found to have developed severe blue-stain disfigurement leading to patchy and discontinuous disfigurement beneath the coating.

The integrity of the coating on the pine boards was found to be severely compromised. Severe flaking and peeling of the coating had occurred not only along the rounded shoulder details but also on the flat faces where surface fissures and checking had occurred.
