# WEATHERING

# ABOUT ACCOYA®

V08.15 – these guidelines have been written for professionals wishing to use Accoya to create beautiful, reliable and highly durable end products. Should you require further information or have any comments about this document, please contact Accsys through [www.accoya.com](http://www.accoya.com).

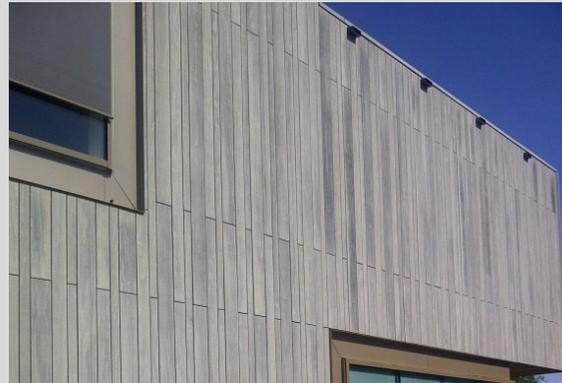
An example of such a blotchy transition period is shown in the image above (Dutch cladding project approximately a year after installation).

However, prior to turning grey, uncoated Accoya will go through a phase of bleaching where it turns a lighter shade of its normal colour. Surface growths are particularly apparent in this intervening period and can vary in level from board to board. This will become less distinguishable and objectionable after full (even) greying, but in this transition period the surface of Accoya may look blotchy.

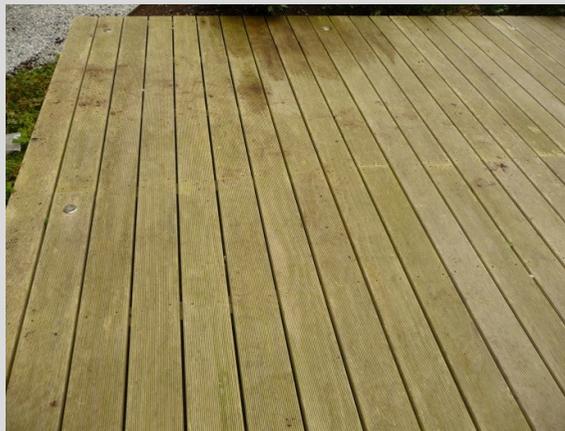
Shaded areas may promote development of algae.

A wet and a dry board may vary in appearance. Due to the installation details, the presence of a shaded area and the natural differences in the wood between boards, as for instance density variation or grain orientation, some may dry quicker than others.

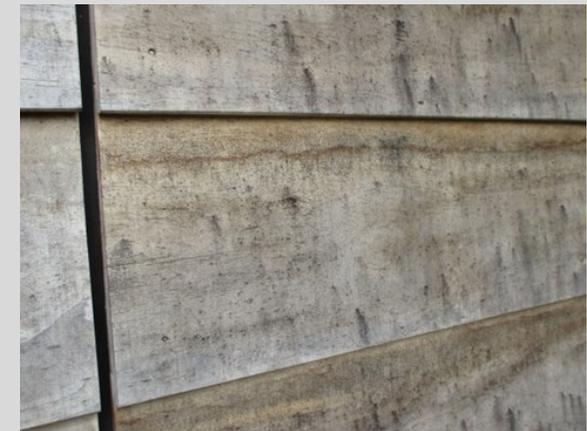
Rough sawn surfaces are more conducive to build-up.

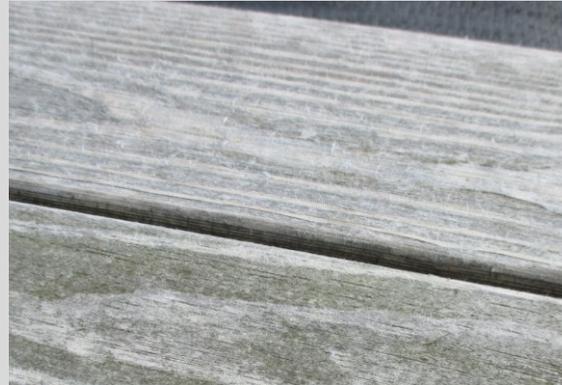
Natural occurring surface fibres on decking.

The higher the amount or intensity of UV the surface is subject to, the faster this process will develop. It should be noted that these fibres are formed on all exposed wood species, including Accoya, particularly on flat surfaces like decking. A ribbed deck profile will tend to cause an accumulation of these fibres, making it all the more noticeable.

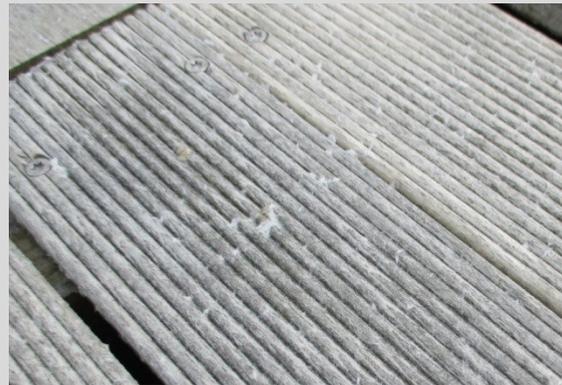
Fibres may get trapped in ribbed surface profiling.

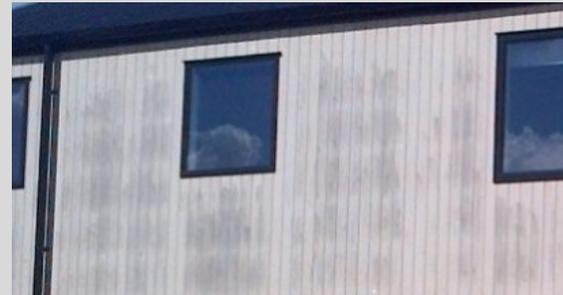
A New-Zealand housing project with a very distinct batten silhouette showing in the cladding surface.

Dryer conditions mean less mould growth, which is why the interfaces are clear where the rest of the board surface shows mould. Note that this effect can be observed on any façade with any kind of cladding or panelling material.

Some projects have shown a distinct pattern reflecting the sub-frame behind the Accoya. This is caused by heat transferal from the building to the Accoya boards, which will decrease the average moisture content at the location of the interface.

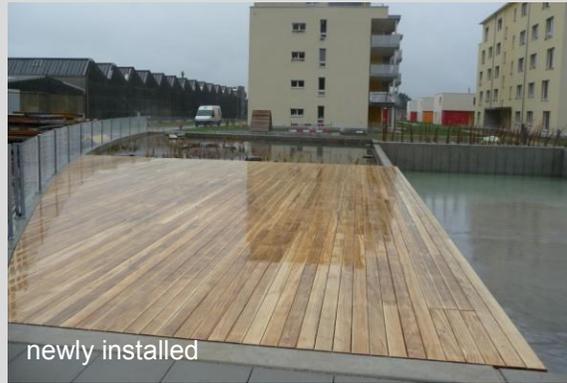
This deck in Oesingen was photographed when newly installed (left), after 10 months (middle) and after 30 months of weathering (right).

**PUBLIC POOL DECKING,  
OESINGEN, SWITZERLAND.**

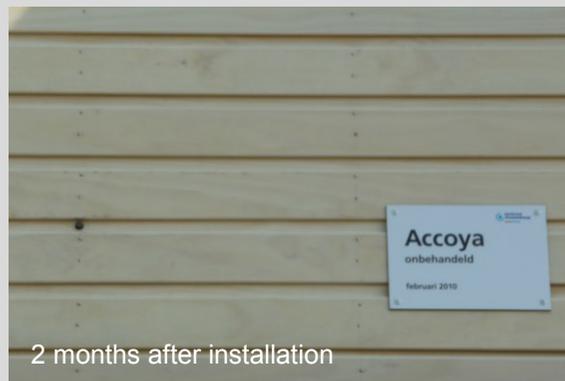
2 months after installation

A part of the South facing façade was cladded with Accoya in April 2010, with no maintenance since. The pictures below (left to right) show this cladding in July 2010, 2012 and 2014.

**OFFICE CLADDING, VROOMS-  
HOOP, THE NETHERLANDS**

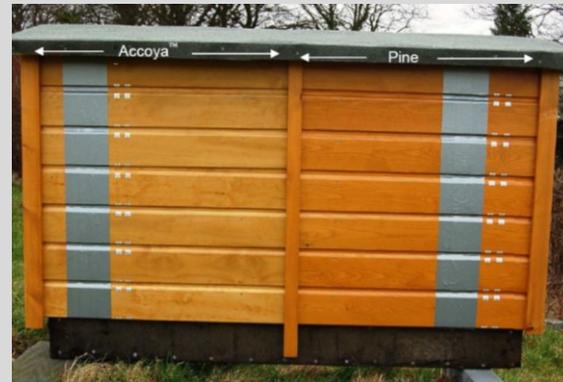
A south-facing cladding rig was set up at BM Trada for the comparative performance evaluation of Accoya and unmodified pine coated with a semi-translucent stain.

The translucent stain system consisted of a pigmented primer with two topcoats. The cladding boards used were machined to a rebated shiplap profile with the upper edge rounded to a radius of  $\pm 10\text{mm}$ .

Test set-up at the start of the exposure in February 2008

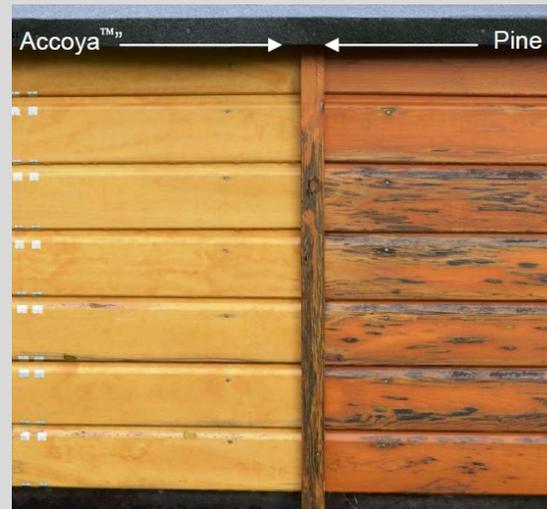
After nearly 7 years of south-facing exposure in a challenging environment the Accoya boards were found to be in a largely serviceable condition with only 2 of the 7 cladding boards showing discernible evidence of stress in the form of mould or mildew growth.

The pine boards were found to have developed severe blue-stain disfigurement leading to patchy and discontinuous disfigurement beneath the coating. The integrity of the coating on the pine boards was found to be severely compromised. Severe flaking and peeling of the coating had occurred not only along the rounded shoulder details but also on the flat faces where surface fissures and checking had occurred.

Test set-up after 7 years of exposure in January 2015
