High-performance exterior MDF

ABOUT THE PANEL

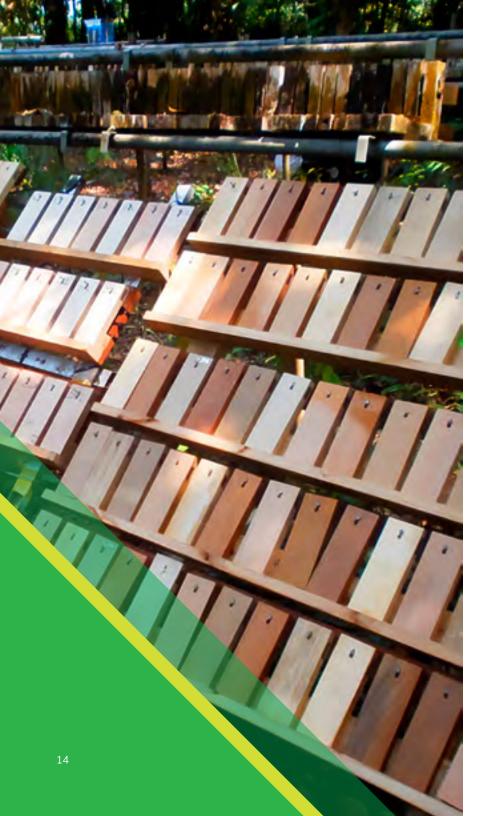
BORNEO

The above-ground H3 flat panel field trial was installed in 2014 at The University of Malaysia test site in Borneo. Year round high temperatures and monthly rainfall make this a particuarly aggressive site for wood decay.

The wood types in the test were assessed by an ASTM 10 point visual decay assessment . The inspection reported here was in August 2023 after 9 years exposure.

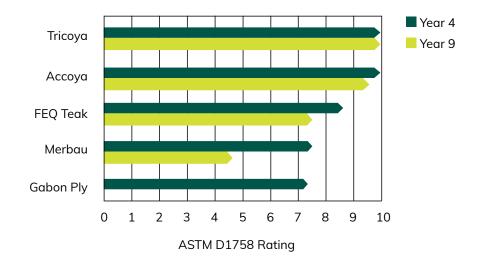
Flat panel above ground

The Accoya and Tricoya outperformed the other traditional durable timber options and demonstrated their Durability Class 1 credentials.

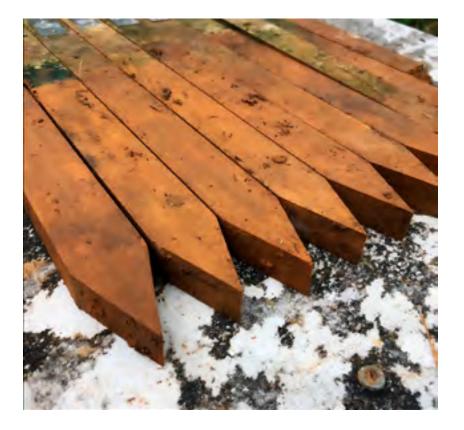
OKINAWA

Tricoya and a range of durable wood types were installed at an independent test field on the Island of Okinawa, Japan. The site was chosen due to its high rainfall and temperatures creating an ideal environment for termites and decay. After 4 years in could contact, the uncoated Tricoya panels samples can be removed from the ground contact exposure with no visible damage and the sharpness of cut edges retained. All other durable woods tested suffered wood decay and termite attack.
